The Hydrogeology of the Silverton Creek Watershed

November 3, 2016

Prepared for
Slocan Lake Stewardship Society
By
Richard Johnson and Susan Johnson
Opus Petroleum Engineering Ltd.

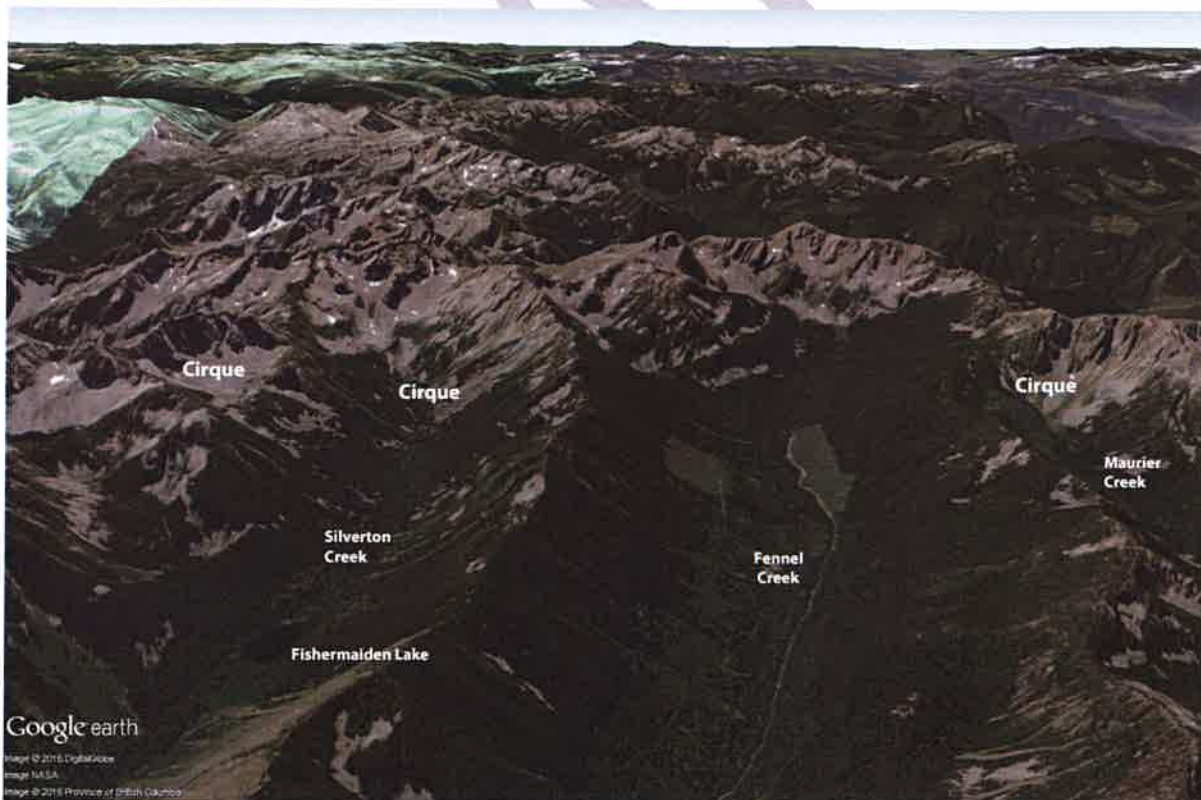
The Silverton Watershed begins with three valleys that start at their high end with typical glacial cirques, often containing a tarn (lake). The picture below, from Google Earth, shows the south end of the Silverton Creek watershed, looking south. The south end of Maurier Creek can be seen on the extreme right hand side of the image, with a labelled cirque at its head. The image was taken in July 2015 and is draped over the Google Earth elevation data. Some of the nicely defined cirques have been labelled.

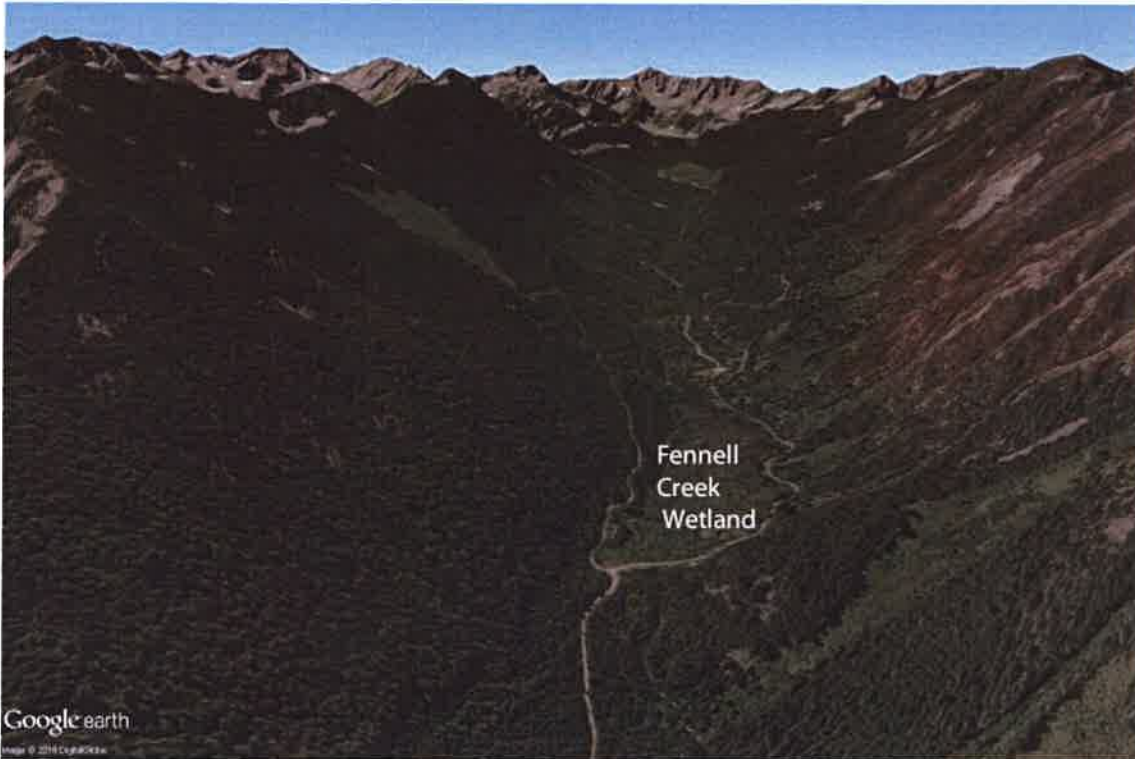
Below the cirques the valleys open into the typical U-shape of glaciated valleys. The sides of these valleys have lateral moraines made up of till (unsorted glacial material).

The large Fennell Creek wetland, shown in the Google Earth clip above (looking south), is interpreted to have been formed by that process. The wetland is the remains of a lake that formed south of the terminal moraine. The north end of the wetland has a lot of sand indicating much washing and sorting of the till occurred here on the shores of that lake.

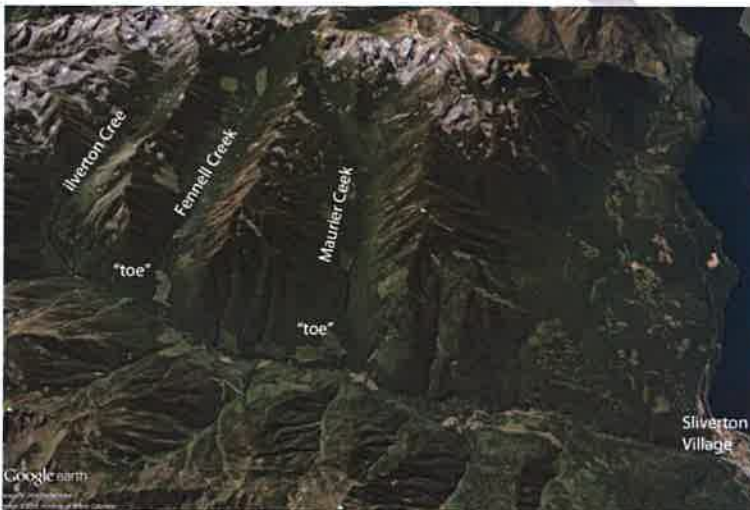
The same thing occurred at the junction of Maurier Creek and Silverton creek. One can see the shape of a “toe” at the northwest end of both these ridges. The low slope indicates underlying till rather than scoured bedrock.

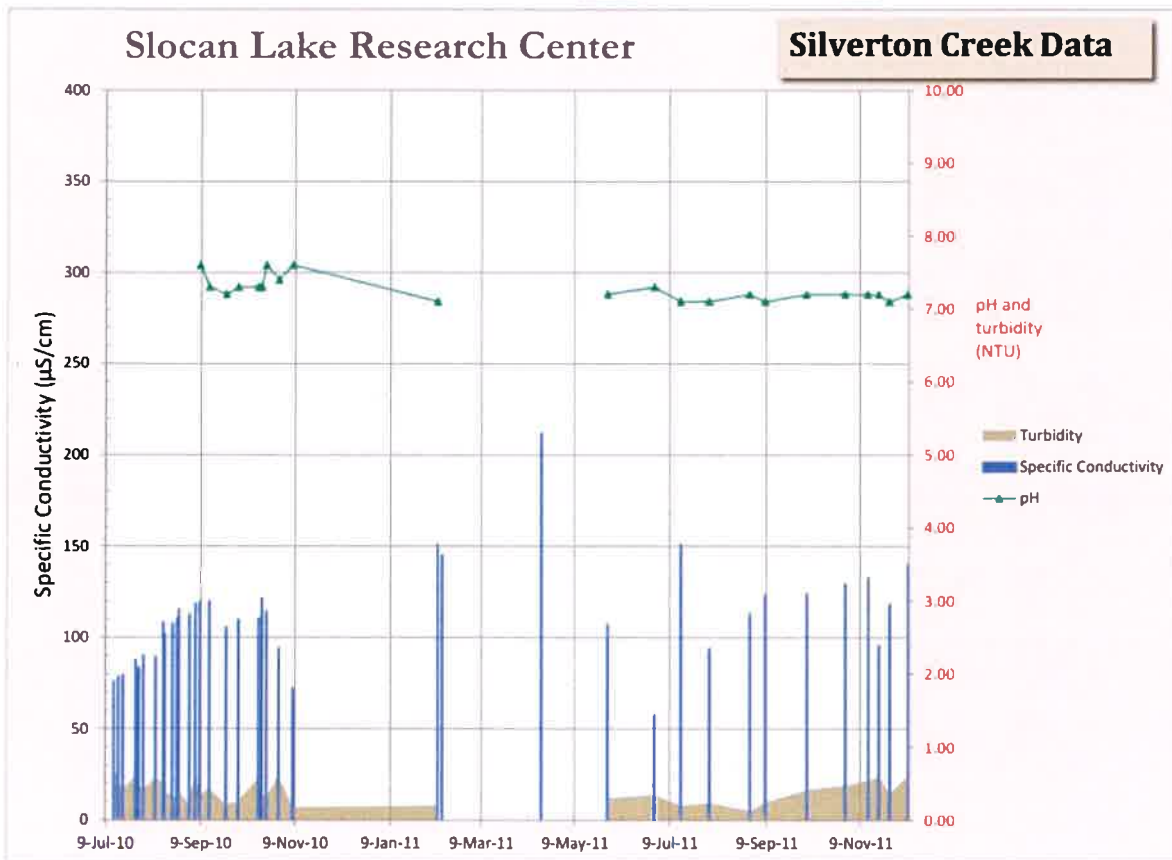
Water samples were taken from Silvertown Creek during the period July 2010 to December 2011. Measurements were made of Conductivity, pH and Turbidity. The graph below shows the variation of these parameters during that time period.

The water samples, shown on the previous graph, were taken from Silvertown Creek (at the Highway 6 Bridge). They have a Specific Conductivity varying from 57.6 microsiemens (June 29, 2011) to 151.1 microsiemens (Feb 22, 2011). The 2015 water samples, shown in the next table, fall in the same range. This range corresponds to total dissolved solids (TDS)

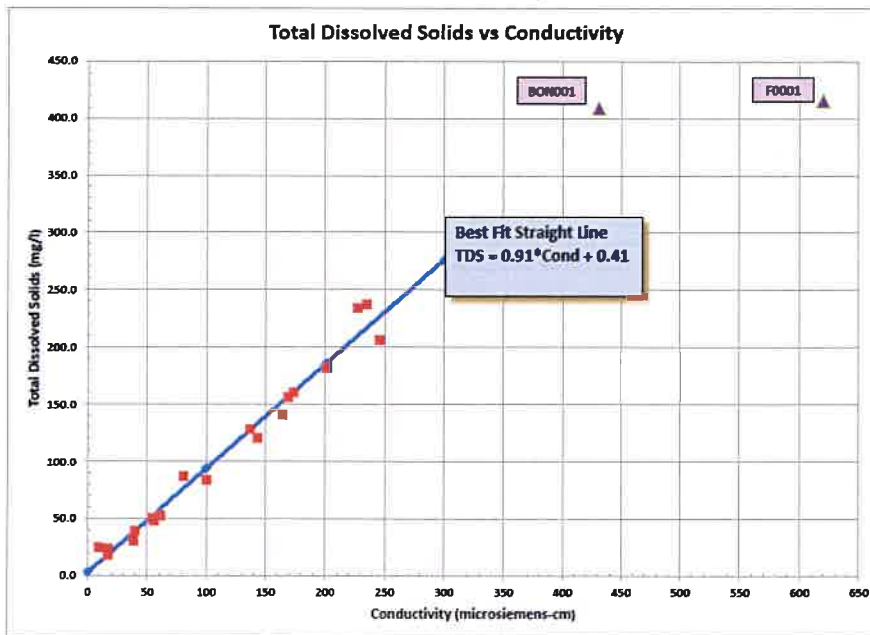
The following graph shows the correlation between specific conductivity and Total Dissolved Solids in the Slocan area (from Quamme, 2016).

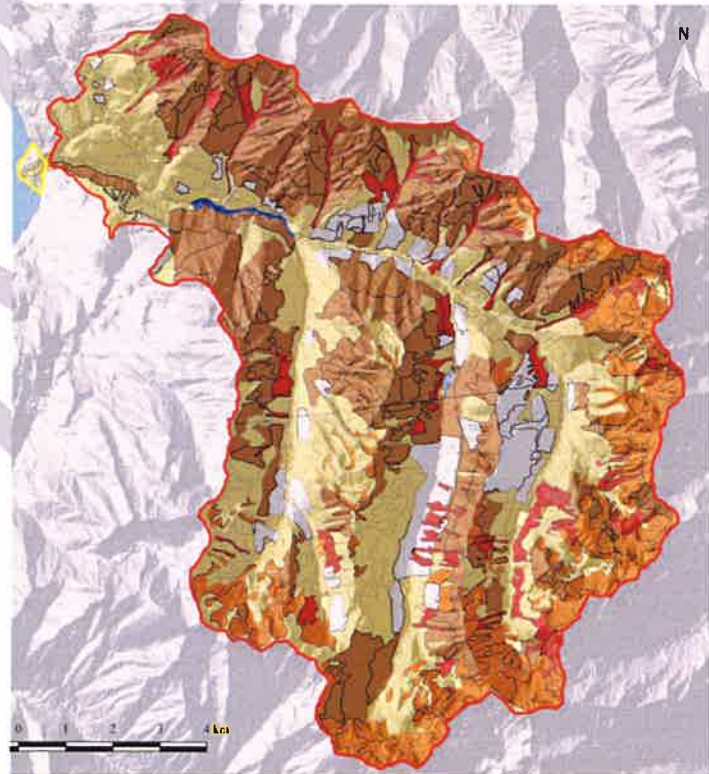
The map to the right, produced from the VRI data, shows the location and type of “modifying effect” that shapes the valley and impacts how the valley can change. In particular, note the red areas which are slopes that are shaped by avalanches. These areas are places that should be monitored to watch for landslides that could impact the water quality by creating turbidity and increasing the total dissolved solids. The brown colour on the map represents areas that are modified by gully erosion. A larger version of this map is shown as Map 4 in Appendix A.

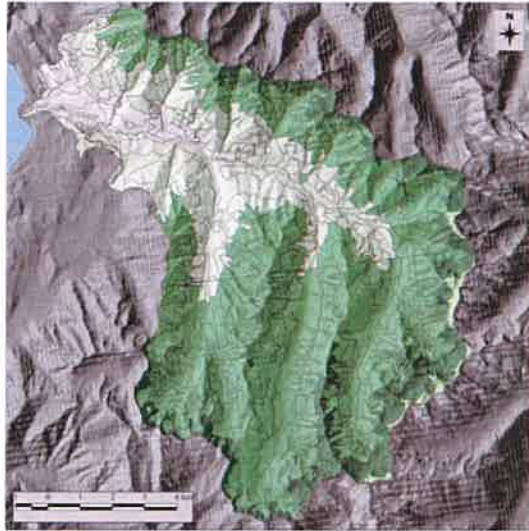
Silvertown Creek Watershed
Biogeoclimatic Ecosystem Classification

The map at the left is from the same database and shows the Biogeoclimatic Ecosystem Classification (BEC) Subzones for the watershed. The location of tree species, plant and animal distribution, birds, insects, lichen and all related interactivity (ecosystems) is related to the BEC zone. The map shows the current classification; with climate change these zones could change. A larger version of this map is shown a Map 3 in Appendix A.

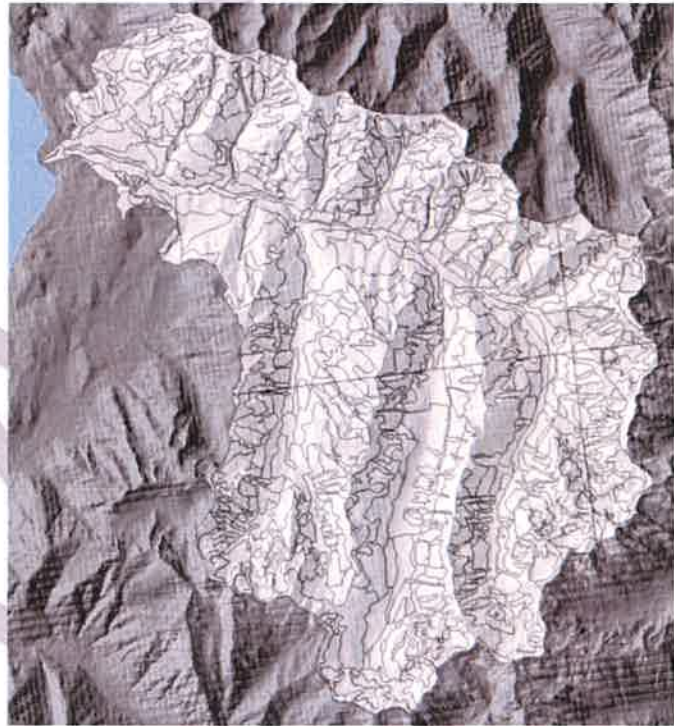
The polygons shown on the map at the right show the amount of detail used for these classifications. There are 762 individual polygons that have been defined for the Silvertown Watershed.

The polygons each have up to 185 fields of data associated with them which allow the user to create maps that classify the vegetation within the polygon as to such things as the age of the trees (1 to 10 plus years), tree heights and diameters, and similar breakdowns that show what the forest is in the watershed.
